OREGON CORNER RESTORATION FORM

Section 2 Township 1S Range 31E
 County Umatilla Date: October 3, 2001

Corner Designation: 1S31A19

North 1/4 section corner to section 2, T1S, R31E,
 W.M., Umatilla County, Oregon.

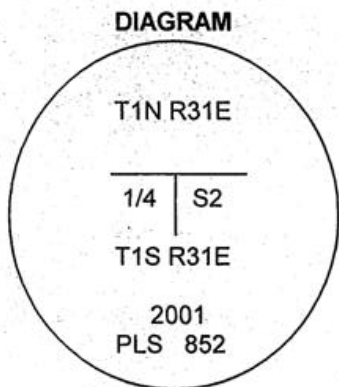
Monument and Accessories found: (condition and source)
 None.

At the proportionate point I set a 30" x 1 1/2" G.I.P. with a 2 1/2" brass cap stamped as shown in the diagram above 20" in the ground. I raised a 3' mound of stone around the cap and set a 5' steel guard post with a County monument sign attached along side.
