OREGON CORNER RESTORATION FORM

Section 26 Township 2N Range 32 E

County Umatilla Date 1-16-90

No 90-03-A Witness

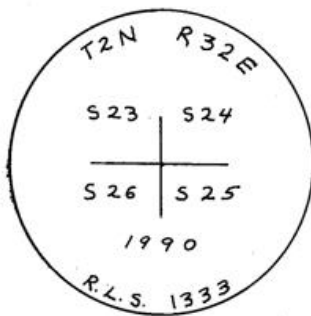
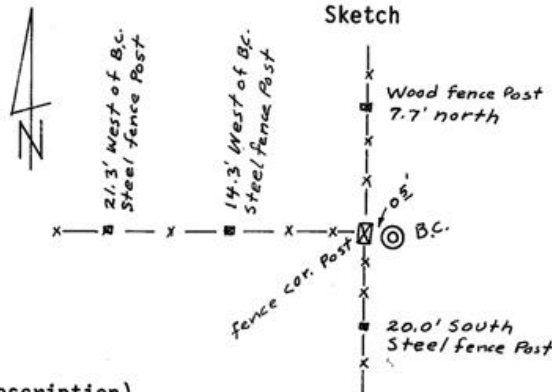
Monument Detail

I found the fence corner Odman used and set brass cap using his bearings and distances, which places the corner 6" east of the existing fence corner post.

Set 1" x 30" G.I.P. w/flared base and 2 1/2" brass cap 6" above the ground and 6" east of fence corner.

1. Good wood fence post bears North 7.7 ft.
2. Steel fence post bears South 20.0 ft.
3. Steel fence post bears West 14.3 ft.
4. Steel fence post bears West 21.3 ft.

Brass cap corner is 6" east of fence corner post. Compass Declination Firm/Agency Don Staebler
