RAILROAD CROSSING SAFETY IMPROVEMENT PROJECT

CROSSING NO. 2AH-188.80 ON COUNTY ROAD NO. 1211, NORTH OTT ROAD, APPROXIMATELY 1 MILE EAST OF HERMISTON, OREGON

CROSSING NO. 2AH-190.10 ON COUNTY ROAD NO. 1203, CANAL ROAD, APPROXIMATELY 2 MILES EAST OF HERMISTON, OREGON

MAY 7, 2013

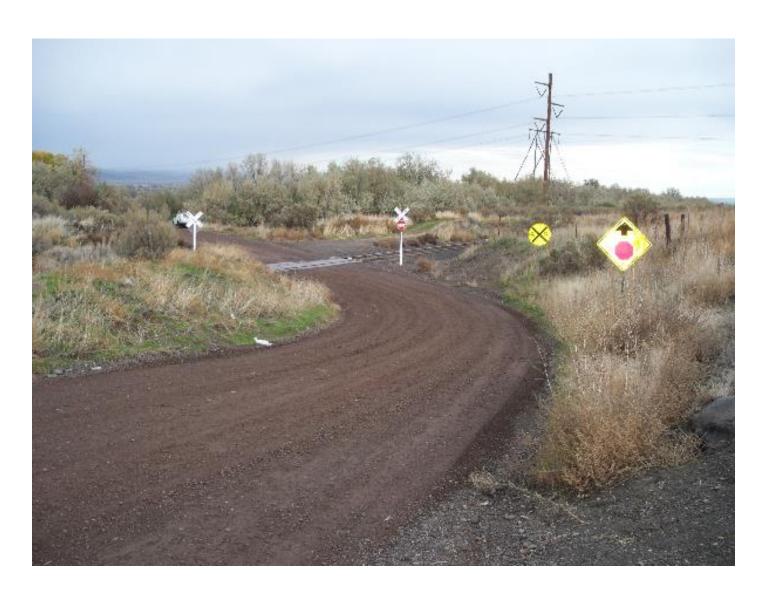
O.D.O.T. CROSSING NO. 2AH-188.80 U. S. D.O.T. NO. 809057R UMATILLA COUNTY ROAD NO. 1211 NORTH OTT ROAD

AT EAST LOOP ROAD NEAR CROSSING LOOKING NORTH ALONG NORTH OTT ROAD

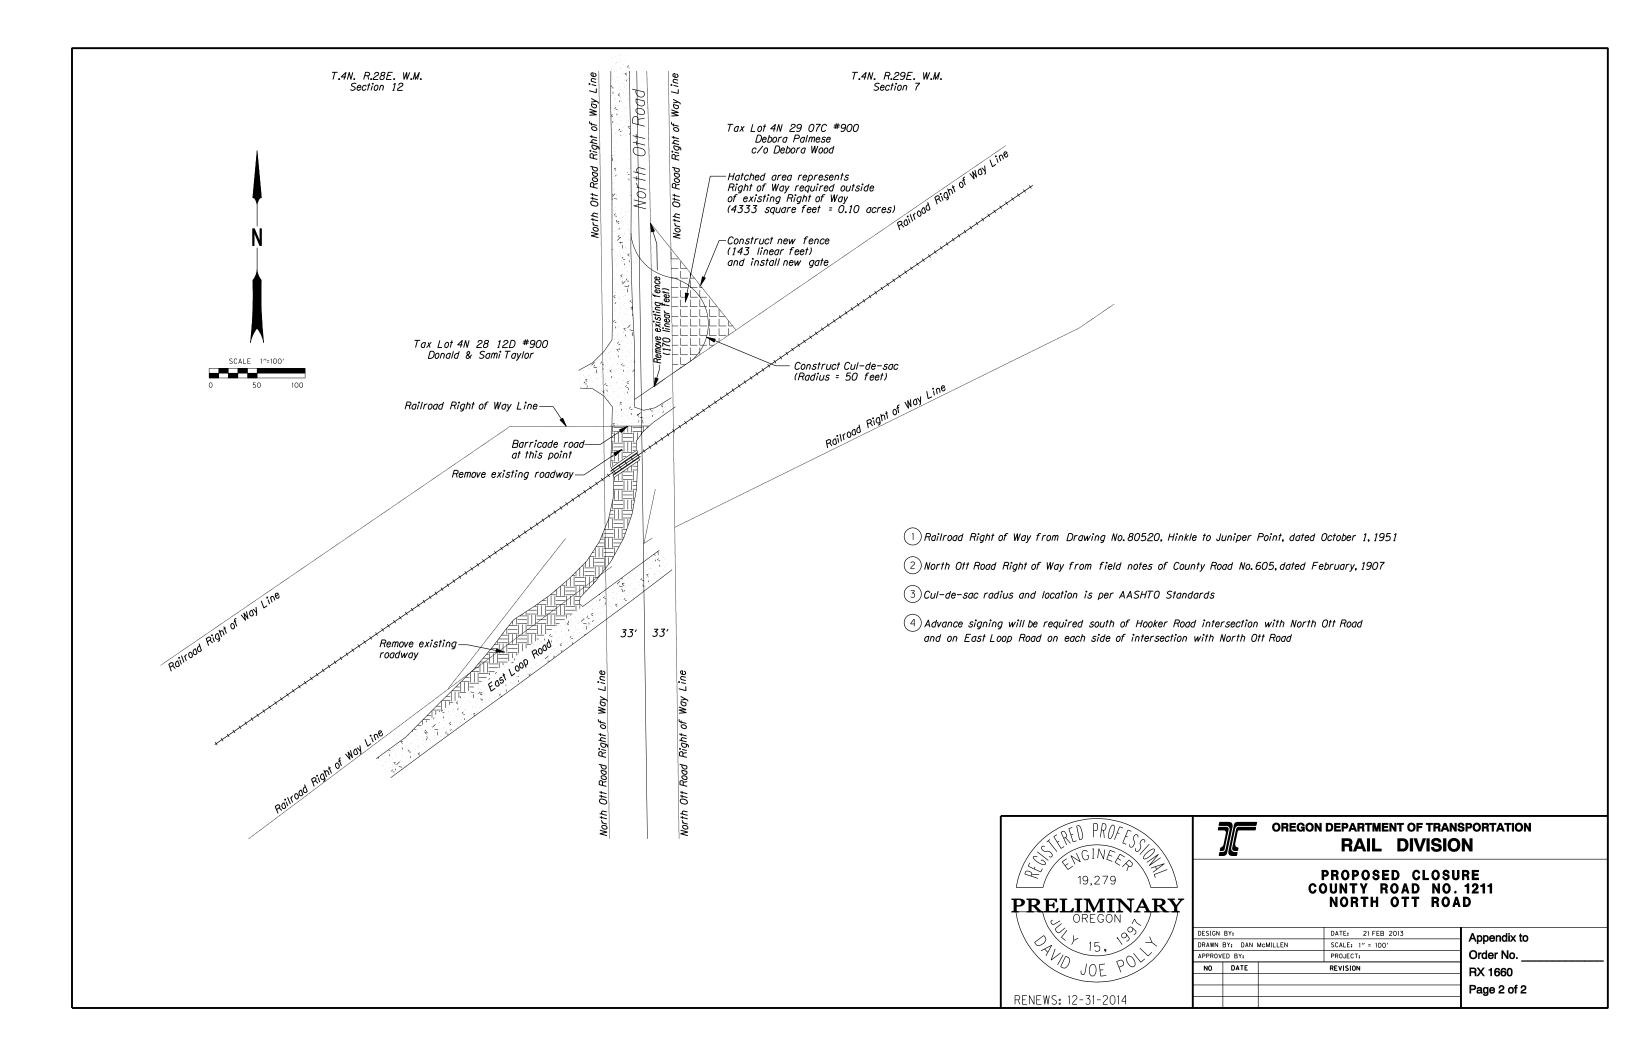
The proposal is to close (barricade) Ott Road at the northerly U. P. R. R. right of way line and construct a cul-de-sac on the east side of the road for turnaround purposes. That portion of Ott Road lying between Loop Road and the northerly railroad right of way line would then be obliterated (see attached drawing and photograph). Advanced warning signs for the closure would be placed along Loop Road east and west of the closure and near the intersection of Ott Road and Hooker Road. Construction of the cul-de-sac would require the acquisition of

approximately 0.10 acre of right of way from Deborah Palmer, who owns Tax Lot #900 on Map 4N 29 07C. Fences and gates would be rebuilt on the new right of way lines.

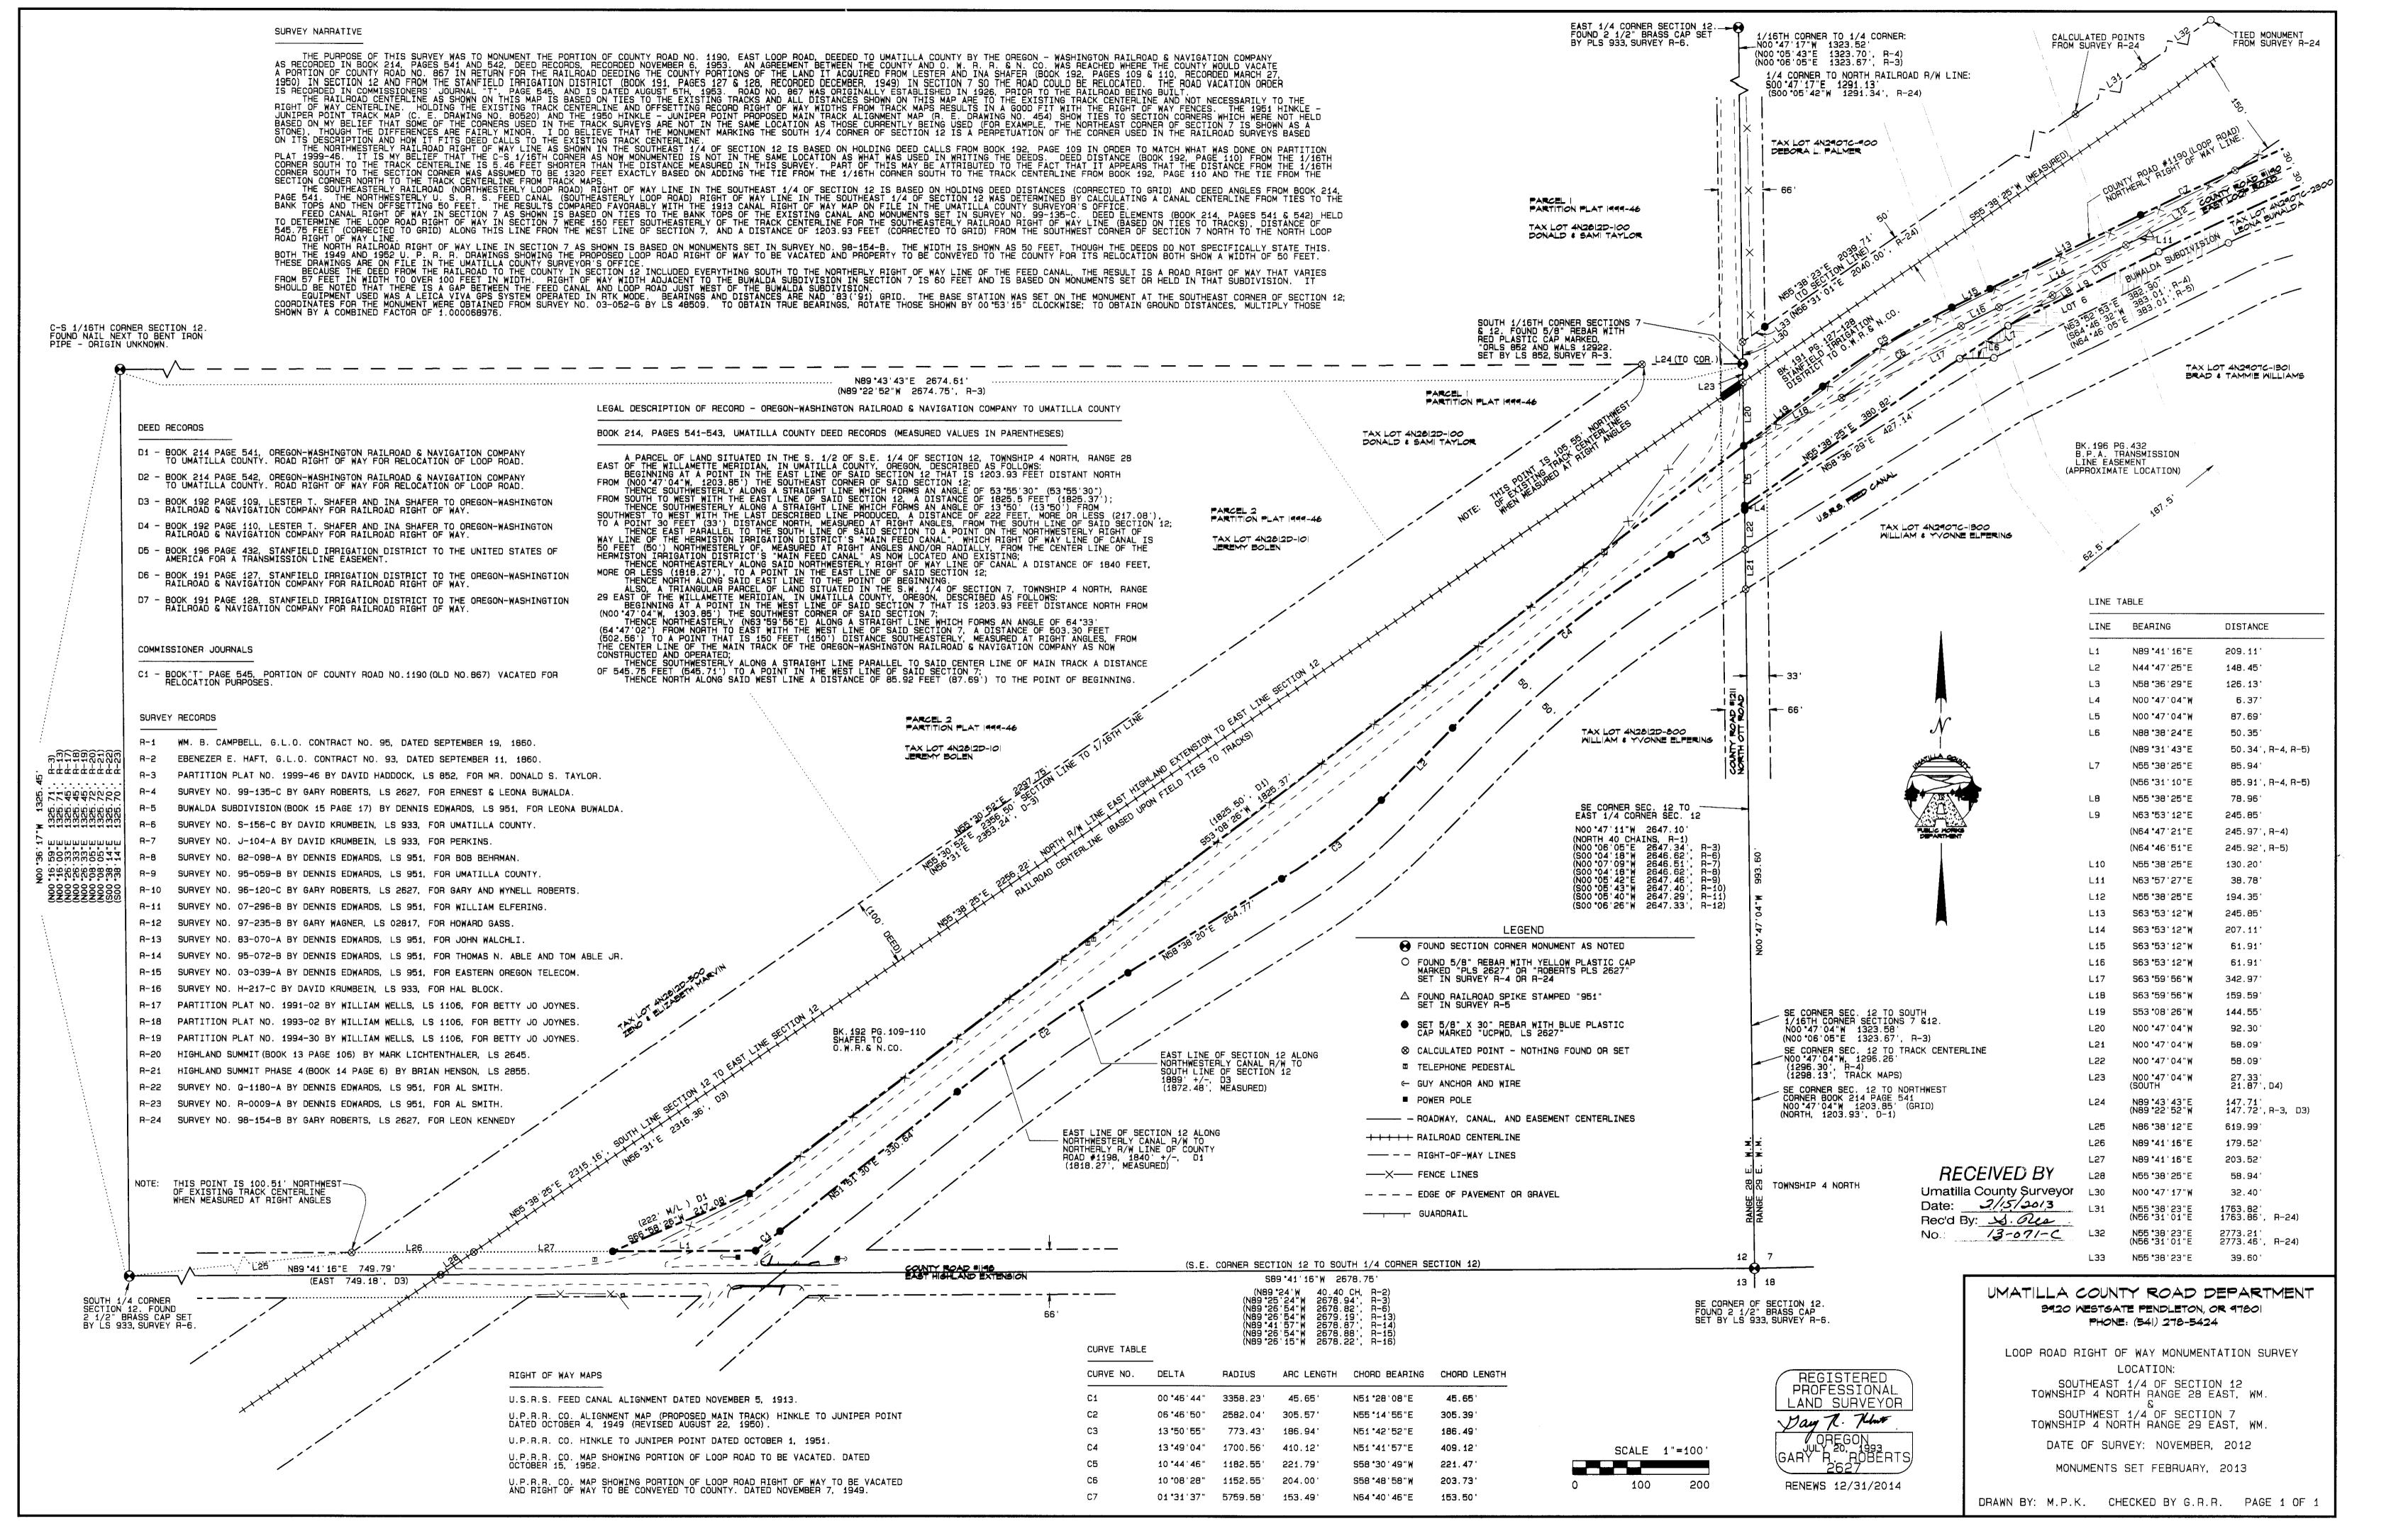
A portion of Ott Road between the crossing and Loop Road is entirely outside of any legal right of way the County has jurisdiction over (highlighted in yellow on the attached survey map); it lies entirely on U. P. R. R. property.

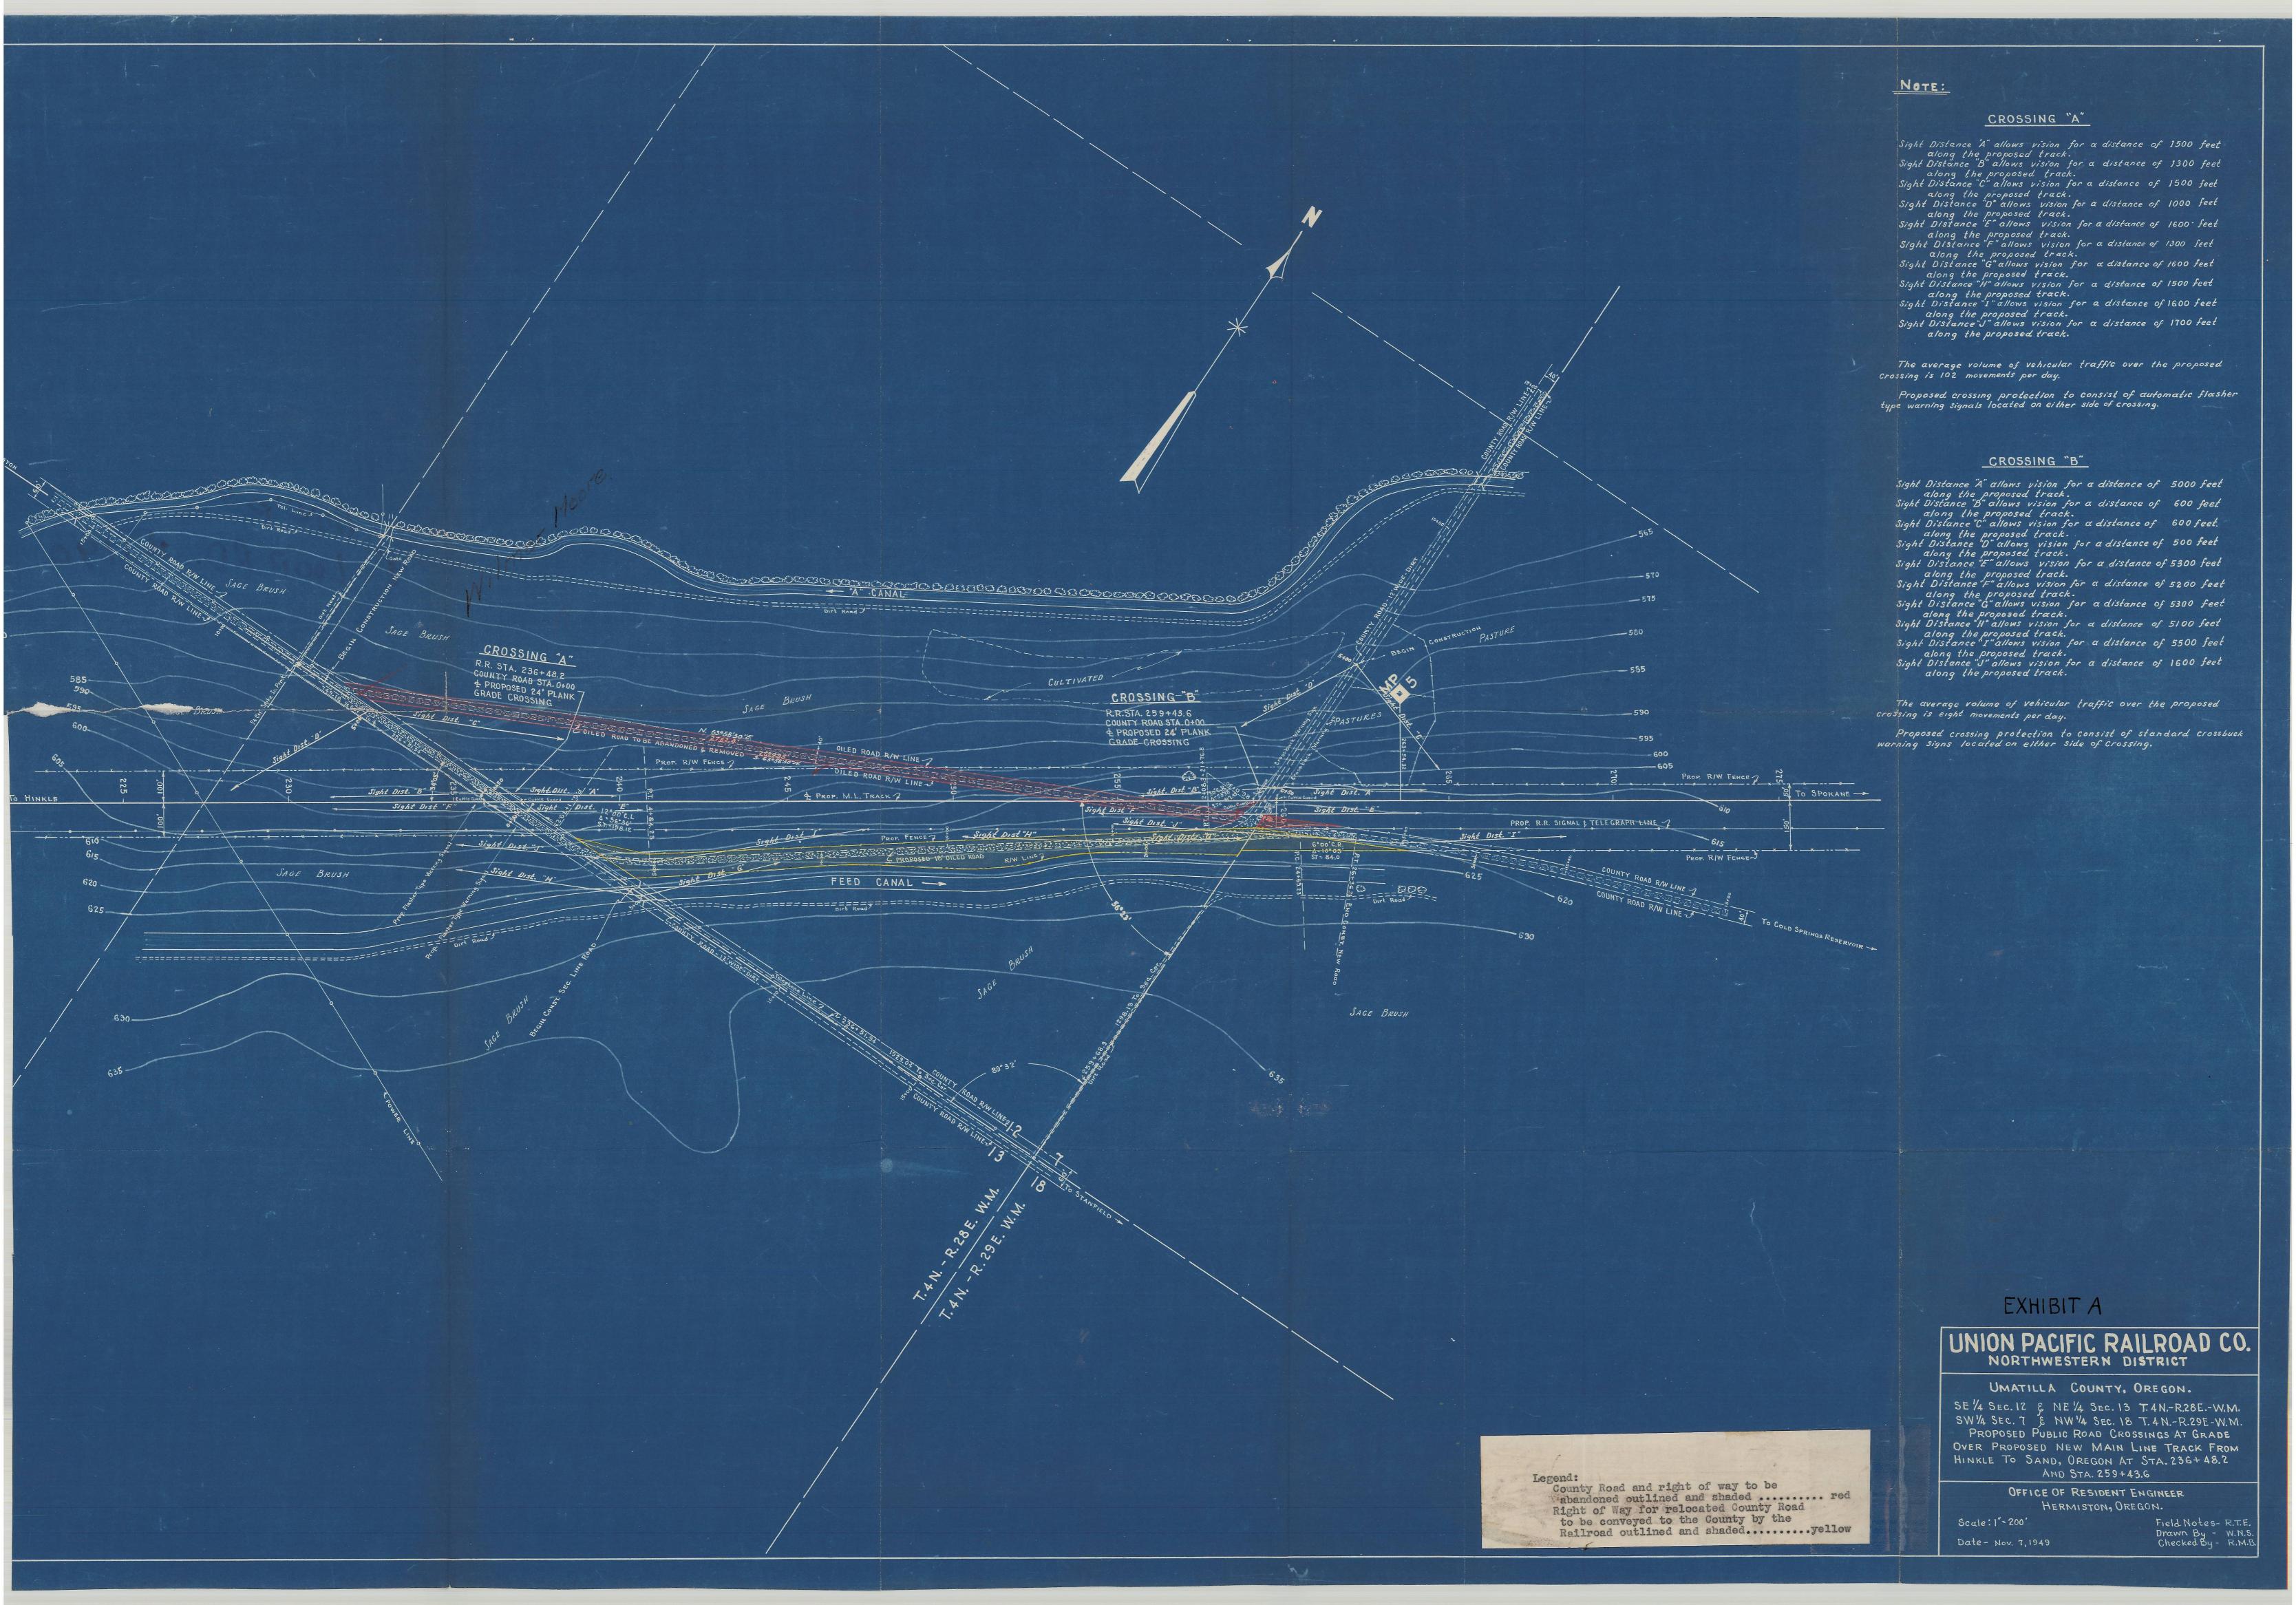
Attached is a 1949 Union Pacific Railroad Map labeled "Exhibit A" showing a proposed vacation of a portion of the existing County Road No. 867 (East Loop Road - highlighted in red) and realignment of the road (highlighted in yellow). At that time Loop Road tied into East Highland near what is now the East Highland/Townsend Road intersection. The new road right of way was deeded to the County by the U. P. R. R. in 1952; the old right of way was vacated in 1953. The North Ott Road crossing is shown on the map as Crossing "B". In the notes on the right side of the map, it says the average daily traffic volume was 8 at this time. A traffic count taken in 2012 shows the volume to be 140 with many of the vehicles being school buses.

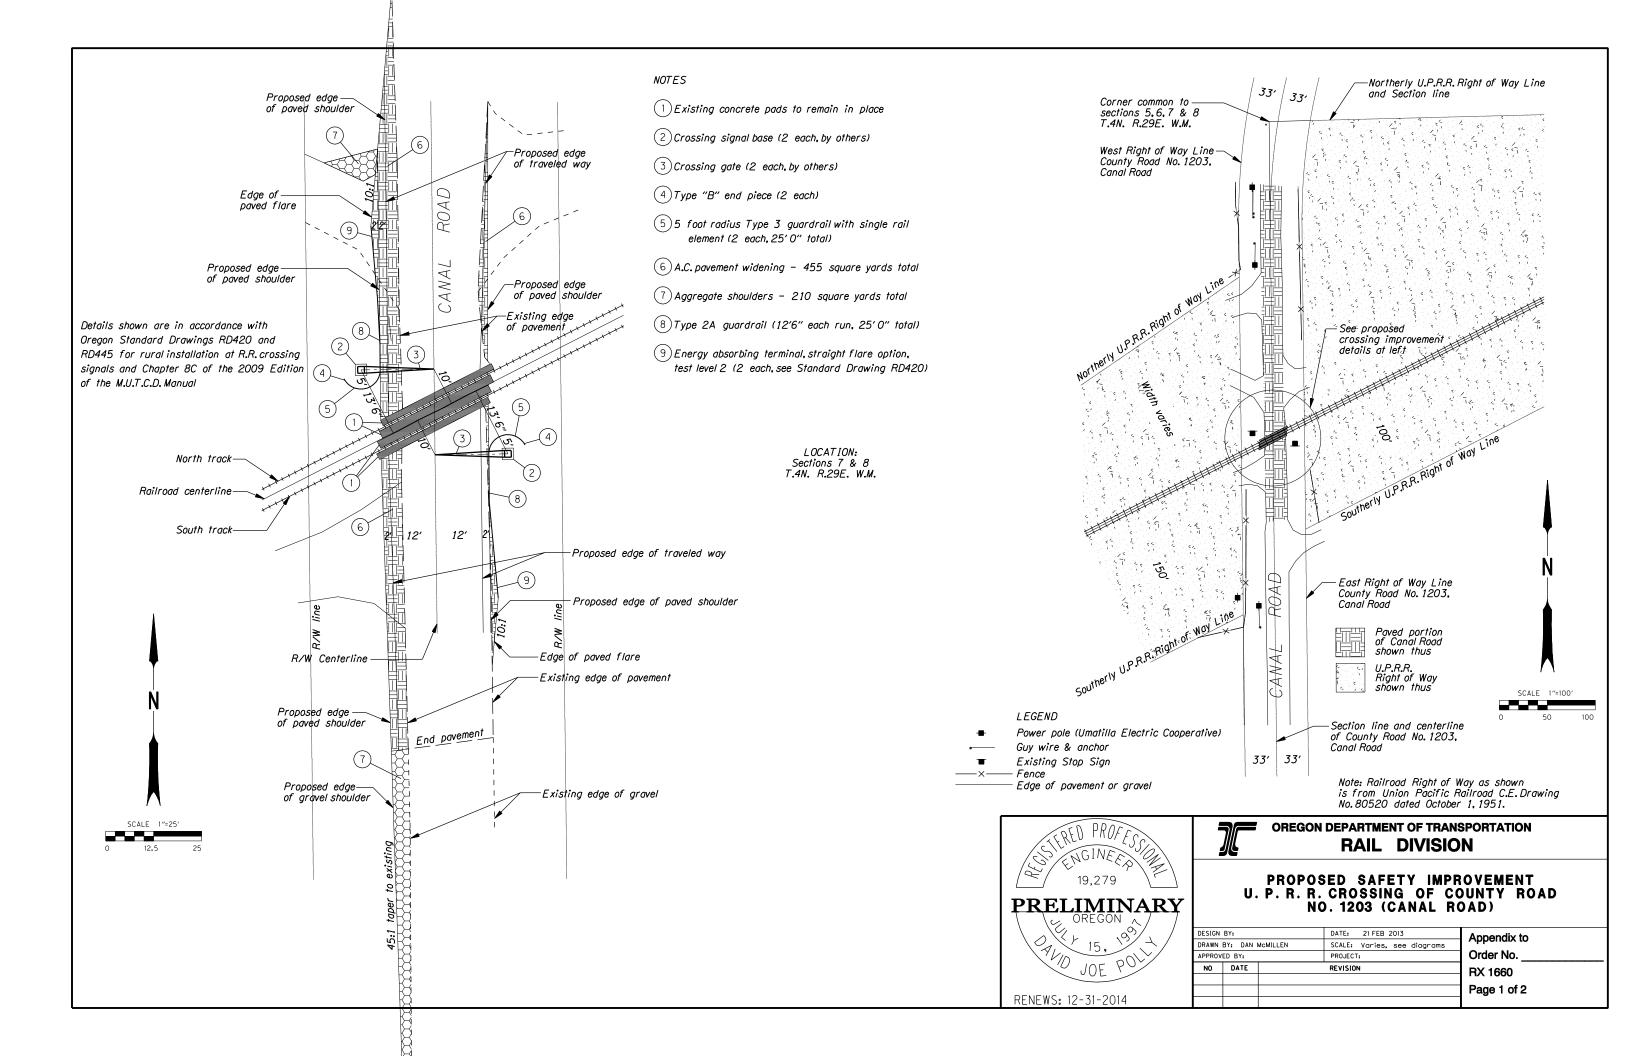
The proposal is to install crossing signals and arms, including guardrail protection and some roadway widening (see attached drawing and photograph). No right of way acquisition will be necessary, as all improvements will be within county road or railroad right of way.
