Index
File No. A-177

CORNER RECORD (SEARCH)

T 1S R. 36E

N.F. UMATILLA State OREGON

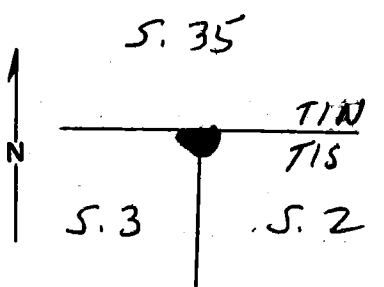
CORNER DIAGRAM

2 1/2" GALV. IRON PIPE WITH 3 1/2" BLM
BR. CAP, IN STONE MOUND, MKD. ->

T1N R36E
S35
S3 | S2
T1S
CL

22" PINE, SCRIBED "T1S R36E S2 BT" BEARS S 73 3/4° E, 49 LWS.
20" PINE, SCRIBED "T1S R36E S3 BT" BEARS S 33 3/4° W, 164 LWS.

LIES IN BOTTOM, AT BASE OF STEEP HILL,
ABOUT 100 FT. W. OF MEACHAM CREEK.

ATTACHED SIGN 54-4 TO BACK OF BT'S.
PAINTED RED BAND AROUND BT'S
SET STEEL POST ABOUT 4 FT. FROM CORNER, WITH SIGN 54-9
