OREGON CORNER RESTORATION FORM

SECTION 25 TOWNSHIP 4 NORTH RANGE 27 EAST

COUNTY : UMATILLA DATE 12/02

SE CORNER

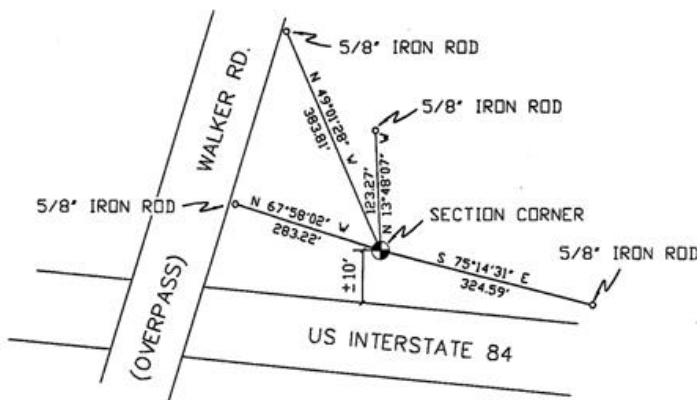
SKETCH

A 3 1/2" BRASS CAP.

- A 5/8" IRON ROD LIES N 13°48'07" W, 123.27 FEET.
- A 5/8" IRON ROD LIES S 75°14'31" E, 324.59 FEET.
- A 5/8" IRON ROD LIES N 67°58'02" W, 283.22 FEET.
- A 5/8" IRON ROD LIES N 49°01'28" W, 383.81 FEET.

FROM INTERSECTION OF WESTLAND RD.
AND I-84. GO EAST ± 280 FEET TO
CORNER, CORNER FALLS ON NORTH
EDGE OF WEST BOUND LANE OF I-84.
