USDA-FOREST SERVICE

CORNER RECORD (SEARCH)

T 675 R. R323E R.D. NORTH FORK JOHN DAY County GRANT-UMATILLA LINE

Merid. WILLAMETTE N.F. UMATILLA State OREGON

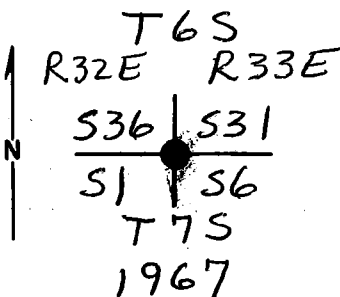
CORNER DIAGRAM

DESCRIBE CORNER MONUMENT FOUND

BLM BRASS CAPPED IRON PIPE. CAP IS MARKED W/ BLM LOGO & AS IN DIAGRAM.

DESCRIBE BEARING TREES OR OTHER OFFICIAL ACCESSORIES FOUND

21" POND, PINE W/ DOUBLE HEATED BLAZES. BEARS N76°E, 20' FEET.
40' HIGH BADLY BURNT SNAG W/ CHARRED SCRIBES VISIBLE BEARS S40°W, 193 FEET.

21" W. LARCH W/ VISIBLE SCRIBES ON PREV. OPENED UPPER BLAZE, HEATED LOWER BLAZE. BRG N8°W, 233 FT

MONUMENT: DESCRIBE NEW MONUMENT SET, OR WORK DONE TO PRESERVE EXISTING MONUMENT

None

ACCESSORIES: DESCRIBE NEW BT'S WITNESS OBJECTS ETC. ESTABLISHED, OR WORK DONE TO PRESERVE EXISTING EVIDENCE

11" DOUG-FIR SCRIBED "T 7S R 33E S 6 BT" BEARS S10°45'E, 72² FT.
21" DOUG-FIR SCRIBED "T 7S R 32E S 1 BT" BEARS S50°W, 77² FT.
